TECHNICAL REPORT 01-01

# EVALUATION OF FLEXIBLE PAVEMENTS IN REGION 5 CONSTRUCTED WITH GRAVEL AGGREGATES

Prepared by:  
Brad Allen & William Skerritt

NEW YORK STATE DEPARTMENT OF TRANSPORTATION  
1220 WASHINGTON AVENUE, ALBANY, NY 12232-0861

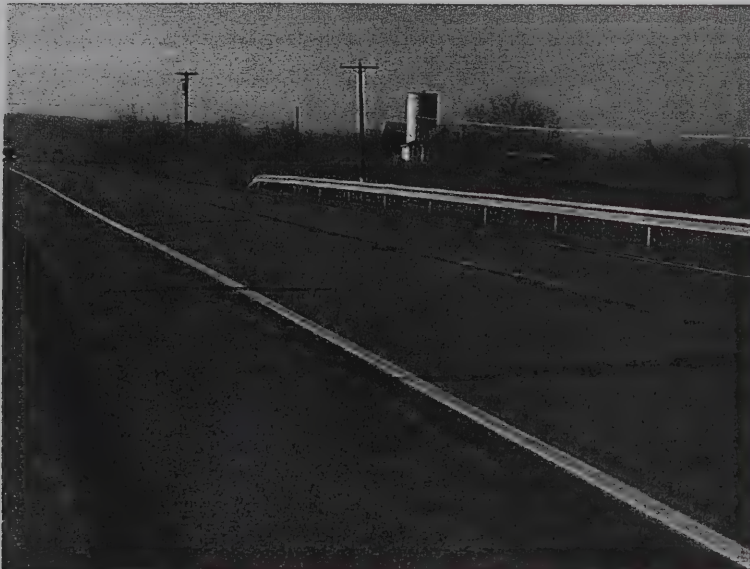
Figure 1 - Regularly Spaced Full Width Transverse Cracking on Route 60

Regularly spaced full width transverse cracking was observed on the entire length of the I-86 project and at Route 60 from RM 60 5201 3095 to 3158. Each of these pavements had extensive areas with moderate to severe full width transverse cracks spaced at 20, 30 and 60 foot intervals. During the document review process these pavements were found to have similar pavement sections and rehabilitation histories.

Both Route 60 and I-86 had previously been rigid pavements. Each had been cracked and sealed and overlaid with HMA; Route 60 in 1984 and I-86 in 1993. The appearance of full width transverse cracking at regular intervals suggests that most of the cracking is reflective of joints and midslab cracks in the

underlying PCC pavement. The Region's 1991 pavement evaluation report for Route 60 notes that most of the transverse cracking present at that time (approximately the same quantity and severity of cracking present today) was reflecting from the original joints in the underlying PCC pavement.

The appearance of reflective cracking on these pavements suggests that crack and seat operation was not effective, and the original pavements are still acting as twenty to sixty foot rigid slabs. This situation is usually the result of either poor treatment selection, or construction practices. The PCC pavement would have been a poor crack and seat candidate, if there was not a significant amount of mid-slab cracking. Construction practices would be to blame if the pavement were not impacted with enough force to fully crack the slab.

For Route 60 there was insufficient evidence in the historical documents to pinpoint the cause of failure, but based to the age of the pavement multiple midslab cracks should have been present in 1984. According to the Region's pavement evaluation 1991 report, I-86 had significant slab cracking at  $\frac{1}{2}$  and  $\frac{1}{3}$  points. This suggests that the pavement was an appropriate candidate for crack and seat. The most likely cause of the full width transverse cracking on both pavements is insufficient impact during the cracking operation. Insufficient impact energies were common on crack and seat projects prior to the Department's purchase of a Falling Weight Deflectometer (FWD) in 1994. The FWD is now used on all crack and seat projects to establish the proper drop height of the cracking guillotine.

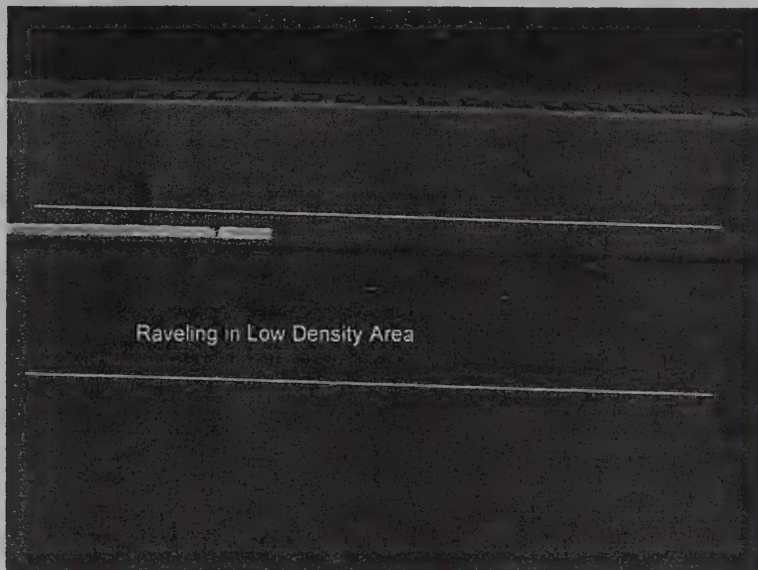
Figure 2 - Distress Concentrated in Driving Lane on I-86

Almost the entire length of I-86 displayed moderate to severe longitudinal cracking along the centerline joint and low severity map cracking in the driving lane adjacent to the centerline joint. Approximately 50% of Route 62, from Kennedy to CR 318 displayed low to moderate severity longitudinal cracking at the centerline joint.

Cracking at and near the longitudinal joint is usually indicative of poor construction practices. Cracking solely at paving joints is not considered an

indication of aggregate breakdown. Raveling can be caused by poor pavement density or aggregate degradation. Raveling caused by degradation would be evidenced by the presence of broken aggregate particles in the raveled areas. This was not seen during the field evaluation.

Most of the raveling at the centerline joint and map cracking surrounding the joint on I-86 was in the driving lane. According to the construction records, the paving operation was phased to pave the passing lane before the driving lane. When longitudinal joints are not constructed properly, it is common to see most of the distress in the lane paved second, the hot side of the joint.

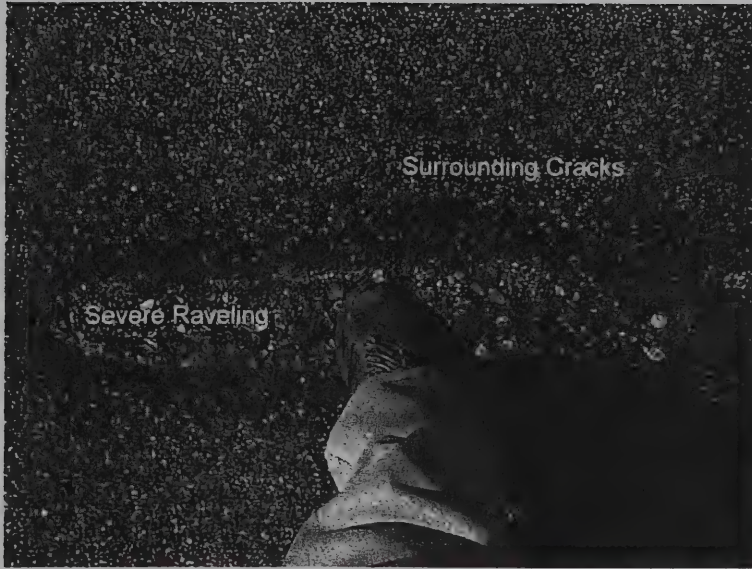
At the time these projects were constructed the specified joint compaction method was to make the initial compaction pass with most of the drum on the previously placed mat, the cold side of the joint, and only six to twelve inches of the roller on the hot side. The roller would then move to the outside of the hot mat for the next pass, and move closer to the longitudinal joint with each subsequent pass. On the final pass some portion of the roller would most likely be on the cold mat.

During the initial pass the roller could only compact the hot side of the joint to the height of the cold side. If the hot mat was not placed thick enough by the paver, the material at the joint would not be sufficiently compacted. If on the final pass any portion of the roller was on the cold side of the joint, the load exerted by roller would be concentrated at the ends of the drum. This would reduce the

Figure 3 - Severe Raveling of Centerline Joint on I-86

roller's ability to compact the material in the center of the drum, the material within one to four feet of the joint. This is commonly called "bridging" the joint.

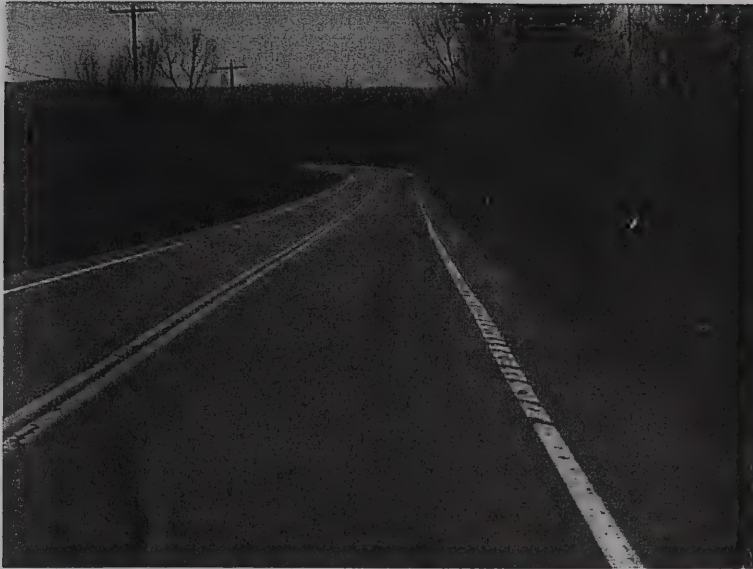
Route 62, north of CR 318, exhibited extensive cracking in the right wheelpath of each lane. This condition was only found from Kennedy to CR 318, the same areas in which the longitudinal joint cracking was present. No wheelpath cracking was present from CR 318 to the Village of Frewsburg.

Wheelpath cracking is usually an indication that a pavement has reached the end of its service life and no longer has the structural capacity to handle the traffic load. If this were the case, cracking would be expected to be present in all wheel paths. On Route 62, cracking was only found in the right wheel path of each lane. The surface texture in the cracked area was also much rougher than the surrounding pavement. Upon close examination it was discovered that the right wheel paths were located at the approximate center of the paving passes. Open pavement texture and cracking along the center of a paving pass are indications of a construction related problem called center-screed segregation.

Center-screed segregation is caused by a concentration of coarse aggregate in the center of the auger area directly in front of the paving screed. The augers are driven by a transfer case at the center of the screed. The location of the transfer case reduces the paver's ability to keep a homogeneous mixture at the center of the screed. If proper paving practices are not followed, this can lead to segregation below the transfer case. Some HMA mixtures are more susceptible to segregation, and some pavers are more likely to cause center-screed segregation, but center-screed segregation can be avoided with proper paving practice.

Figure 4 - Distress Aligns with Center of Paver on Route 62

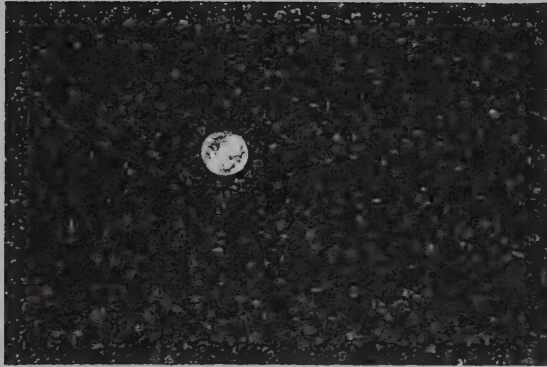
Pocking is generally associated with gravel pavements but often occurs on crushed stone pavements as well. All six of the pavements containing gravel included in this study exhibited pocking to some extent, as did Route 39, which contained crushed stone. Pocking is easily recognizable on gravel aggregate pavements, because gravel is a natural blend of several different types of stone. When these stones are exposed by pavement wear they appear as small spots of different colors, producing a mottled appearance. When pocking occurs on crushed stone pavements it is often difficult to observe, especially from a moving vehicle, because the crushed stone is uniform and often grey in color. Figures 5 and 6 demonstrate the difference in appearance between pocked pavements containing gravel and crushed stone aggregate. The amount of surface aggregate loss is similar, but it is much more noticeable in the pavement containing gravel.

Figure 5 - Pocking on Route 62

There were no pavements in this study where pocking was found to be the cause of further pavement distress. Pocking alone is not necessarily a cause for concern. Pocking normally occurs during the first winter season after a pavement is constructed. Following this initial loss of material, pocking rarely progresses.

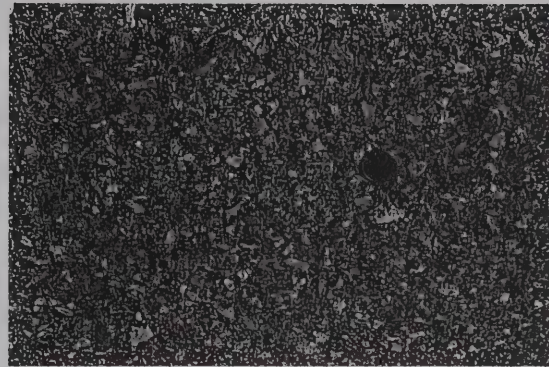
Figure 6 - Pocking on Route 39
